Job Number: Mobberley 091  
Survey Date: 3<sup>rd</sup> & 5<sup>th</sup> October 2025

# Structural Survey & RICS Valuation

**Barnshaw House  
Pepper Street  
Mobberley  
Cheshire  
WA16 6JH**

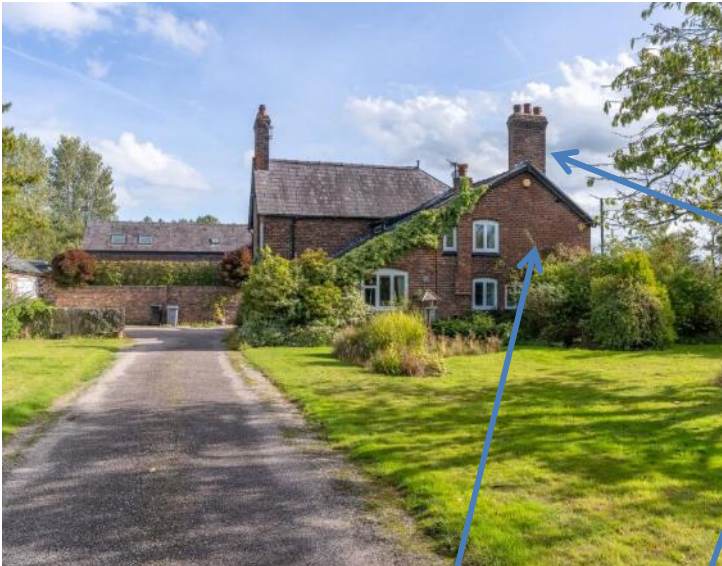
### **Side Elevation**

***Gable end and front corner requiring underpinning***

The remedy for the subsidence at Barnshaw is to underpin around 5m to 6m from the corner of the gable end by the study, both along the front elevation and the gable end elevation, around 10m to 12m of total foundation stabilisation. Underpinning for subsidence is a process that involves strengthening a building's foundations to stop the ground beneath from sinking or moving. We recommend installing a mass reinforced (with mesh) concrete foundation, using traditional concrete injection into trenches, or employing modern resin injection to solidify the soil and fill voids under the foundation. There are many underpinning companies that will quote locally for this work, and it is not a difficult job to undertake at Barnshaw, which has easy workable access to the foundations that require underpinning.

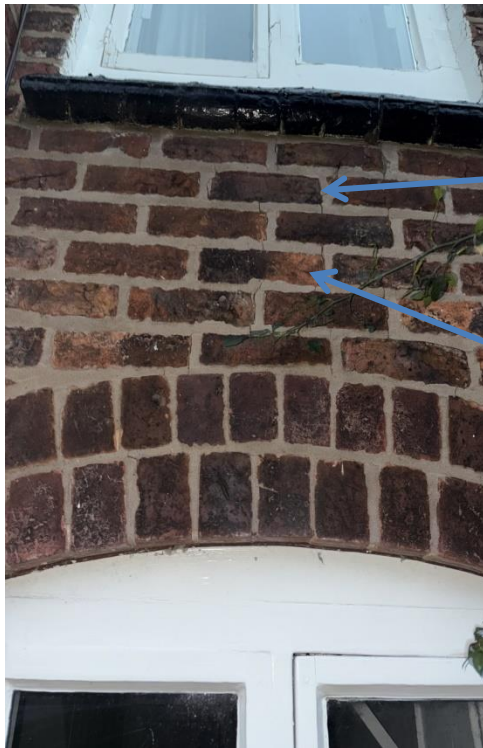
*Settlement vertical cracks*

*Structural underpinning  
required under the Study*

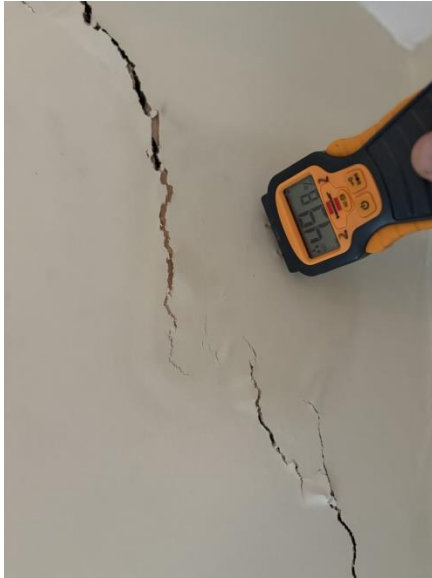
***Cracked and very damp (49%) wall in bedroom 2, below the roof structural purlin.***

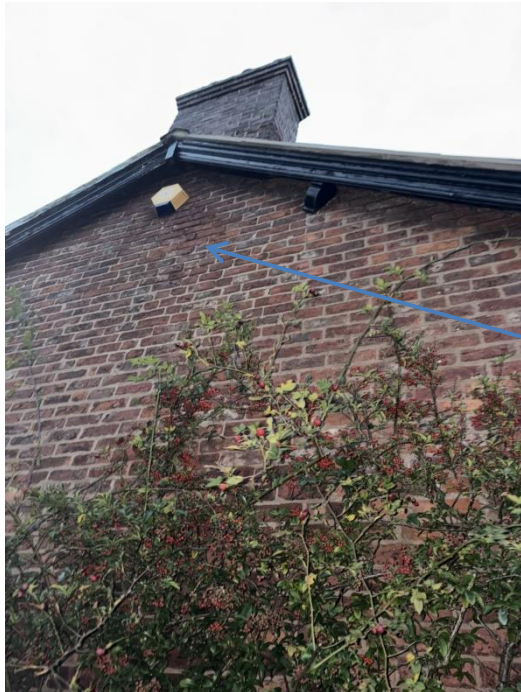
**Vertical stress cracks**

The gable end external brickwork had a number of structural stress vertical cracks on the study wall, which appeared to be progressive following the repointing.

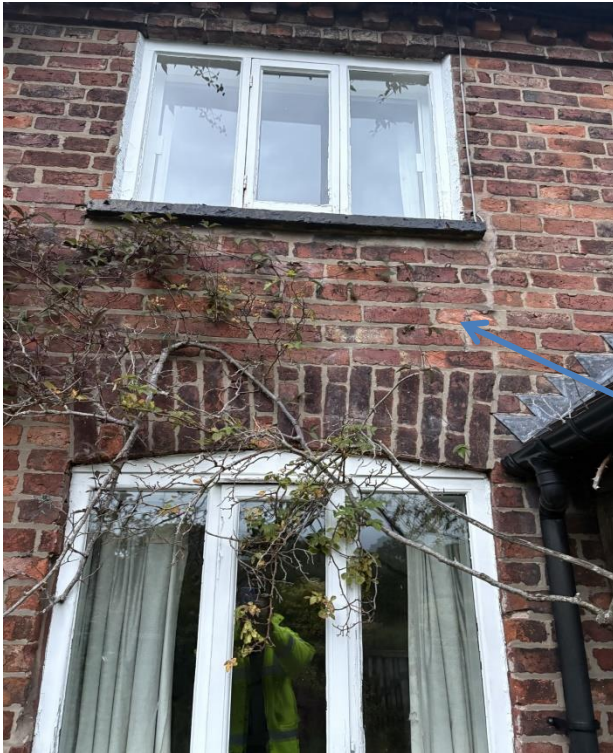
Visible cracks to the front elevation from the principle bedroom down to the lounge below. These cracks have undergone some basic filling over c25 years ago, yet there is evidence that the cracks are still progressive, further indication of continued subsidence is live and on going

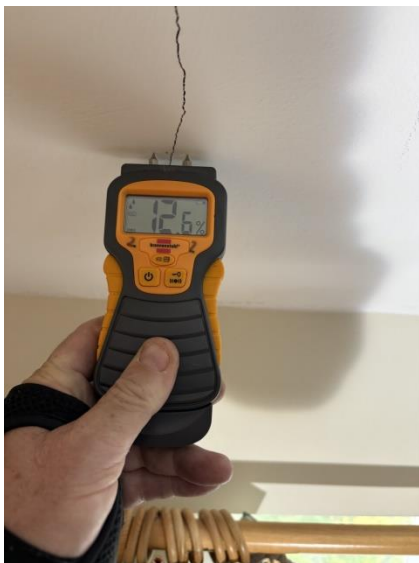
*Bedroom two ceiling*

- Subsidence along the gable and front elevation from both directions from the corner of the study
- Some movement in the two structural roof purlins above bedroom two, which are structurally supported on the said gable end.
