Job Number: Mobberley 091  
Survey Date: 3<sup>rd</sup> & 5<sup>th</sup> October 2025

# Structural Survey & RICS Valuation

**Barnshaw House  
Pepper Street  
Mobberley  
Cheshire  
WA16 6JH**

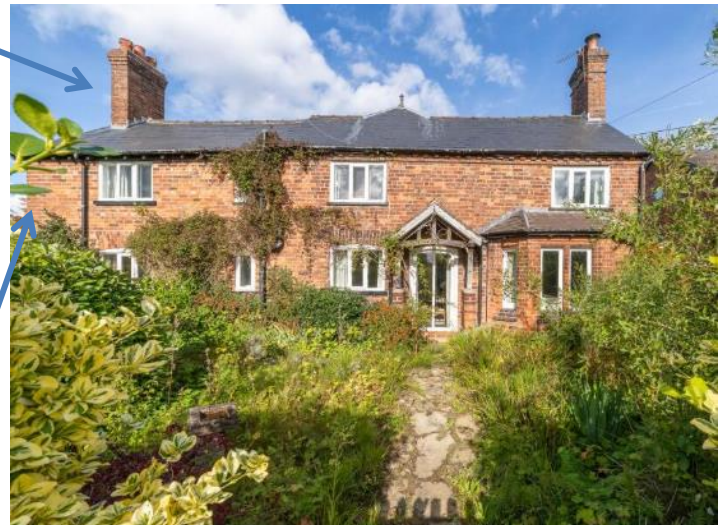
### **Front elevation**

***Gable end and front corner requiring underpinning***

The remedy for the subsidence at Barnshaw is to underpin around 5m to 6m from the corner of the gable end by the study, both along the front elevation and the gable end elevation, around 10m to 12m of total foundation stabilisation. Underpinning for subsidence is a process that involves strengthening a building's foundations to stop the ground beneath from sinking or moving. We recommend installing a mass reinforced (with mesh) concrete foundation, using traditional concrete injection into trenches, or employing modern resin injection to solidify the soil and fill voids under the foundation. There are many underpinning companies that will quote locally for this work, and it is not a difficult job to undertake at Barnshaw, which has easy workable access to the foundations that require underpinning.

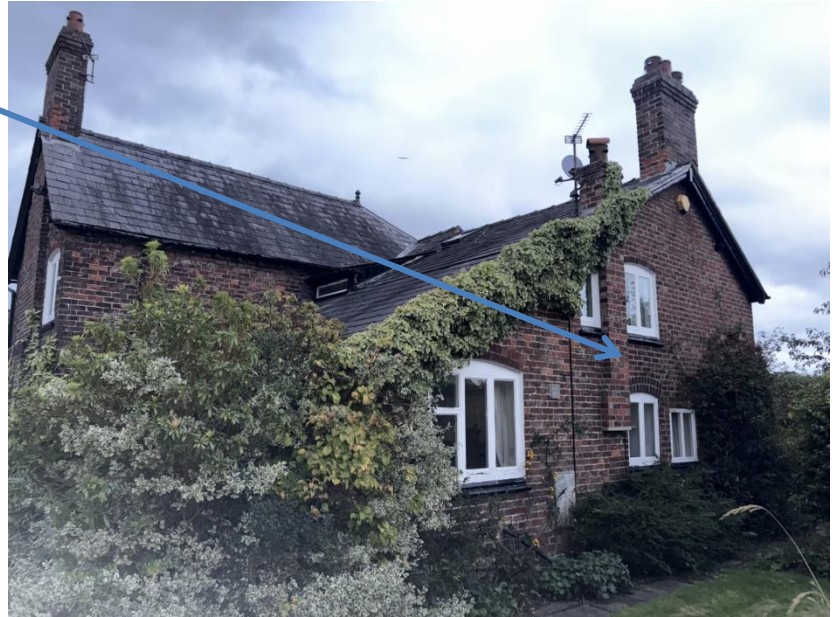
*Settlement vertical cracks*

*Structural underpinning  
required under the Study*

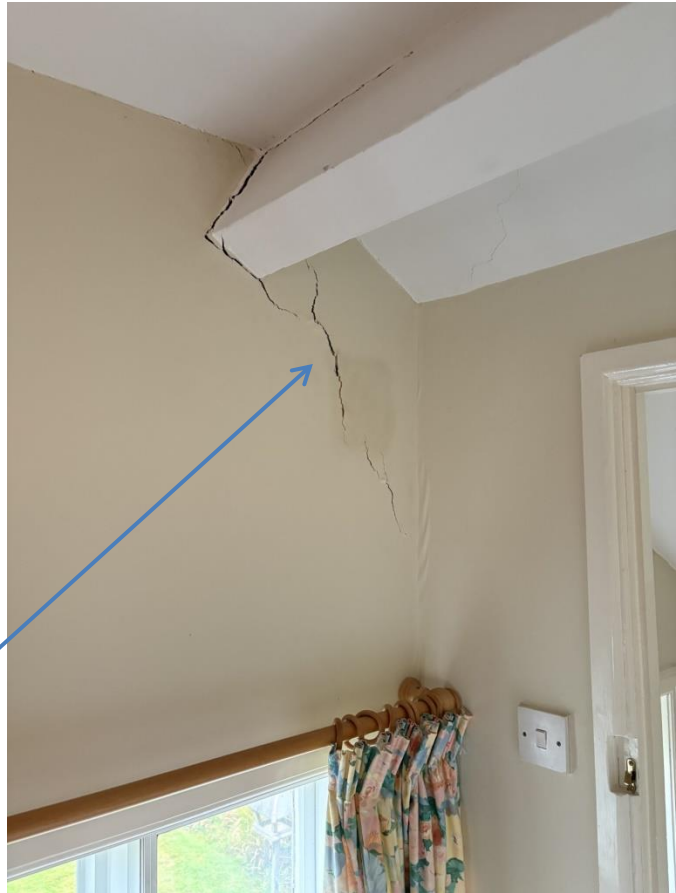
***Cracked and very damp (49%) wall in bedroom 2, below the roof structural purlin.***

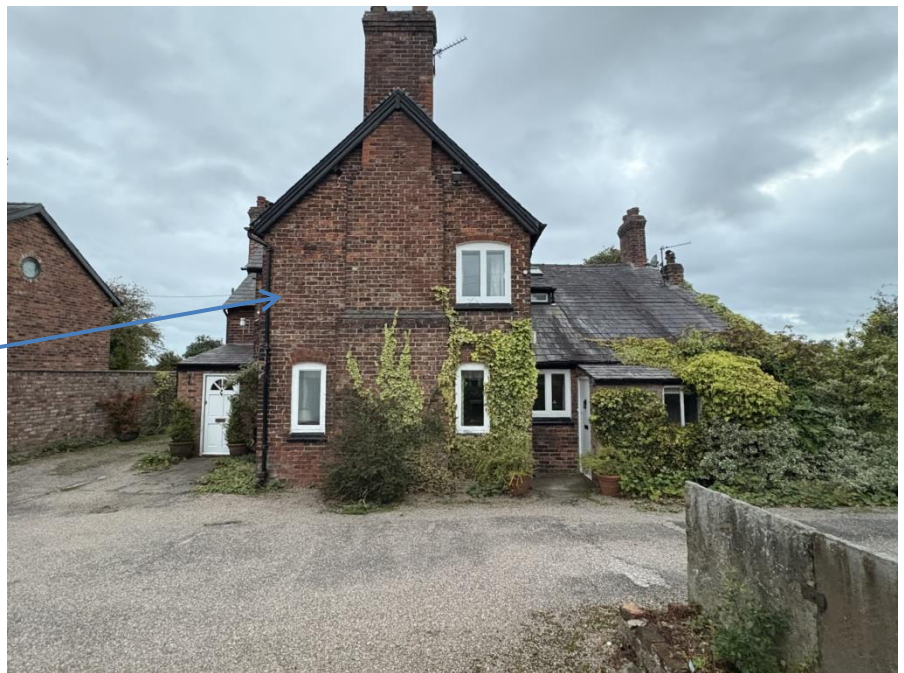
**Vertical stress cracks**

The gable end external brickwork had a number of structural stress vertical cracks on the study wall, which appeared to be progressive following the repointing.

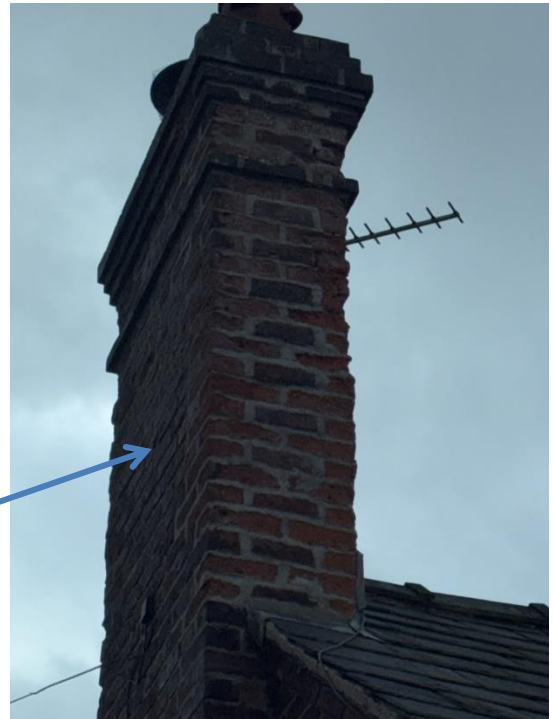
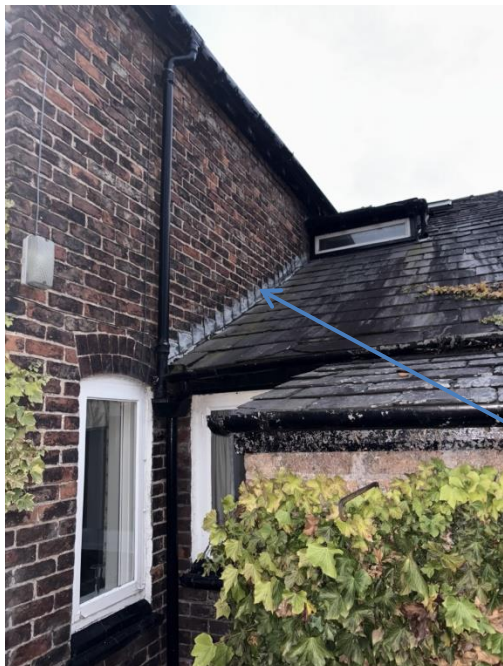
The chimney stacks were in reasonable condition, vertical and the pointing and jointing was satisfactory. The chimney lead flashings require some maintenance improvements to ensure they are water tight.
