Home Report

67 Buchan Drive,
Dunblane,
Perthshire,
FK15 9HW

Single Survey

Property Address	67 Buchan Drive, Dunblane, Perthshire, FK15 9HW
Reference	1073992
Customer Name	Colin McCreath
Date of Inspection	21st May 2025
Surveyor's name, qualifications and office	Gordon McCulloch DipSurv. MRICS DM Hall LLP Chartered Surveyors Suite 2C 1 Pitt Terrace Stirling FK8 2EZ Tel: 01786 475785 email: stirlingresidential@dmhall.co.uk
Prepared By	DM Hall LLP

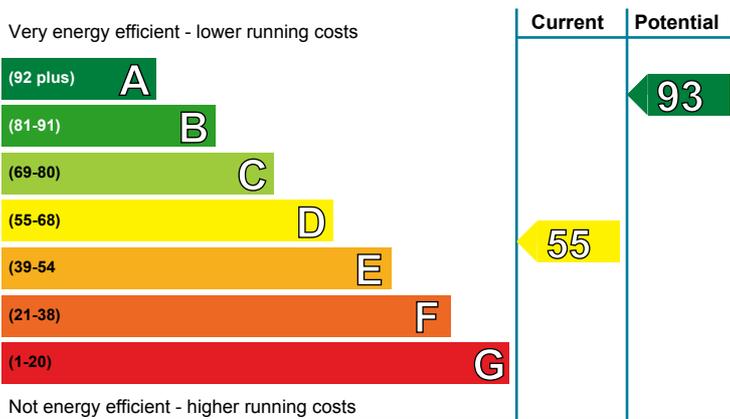
Energy Efficiency Rating

This graph shows the current efficiency of your home, taking into account both energy efficiency and fuel costs. The higher this rating, the lower your fuel bills are likely to be.

Your current rating is **band D (55)**. The average rating for EPCs in Scotland is **band D (61)**.

The potential rating shows the effect of undertaking all of the improvement measures listed within your recommendations report.

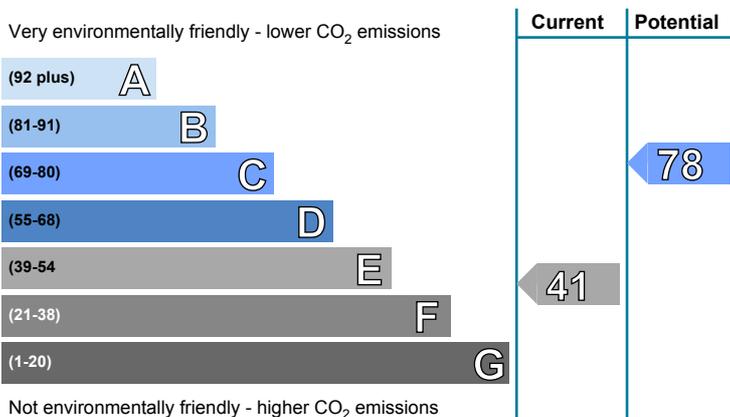
Environmental Impact (CO₂) Rating

This graph shows the effect of your home on the environment in terms of carbon dioxide (CO₂) emissions. The higher the rating, the less impact it has on the environment.
