Home Report

Single Survey

Property address	21 Moray Park Moray Street Doune FK16 6DJ
Customer	Ms Laure Yates
Customer address	21 Moray Park Moray Street Doune FK16 6DJ
Prepared by	Shepherd Chartered Surveyors
Date of inspection	09/08/2024

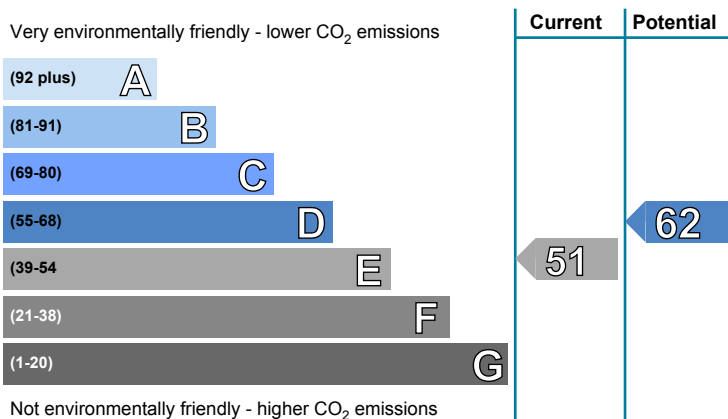
Environmental Impact (CO₂) Rating

This graph shows the effect of your home on the environment in terms of carbon dioxide (CO₂) emissions. The higher the rating, the less impact it has on the environment.
