Home Report

Scottish Single Survey

Property address	13 Rathen Road Inverallochy Fraserburgh AB43 8YB
Customer	The Salvation Army
Customer address	13 Rathen Road Inverallochy Fraserburgh AB43 8YB
Prepared by	Shepherd Chartered Surveyors
Date of inspection	15/09/2023

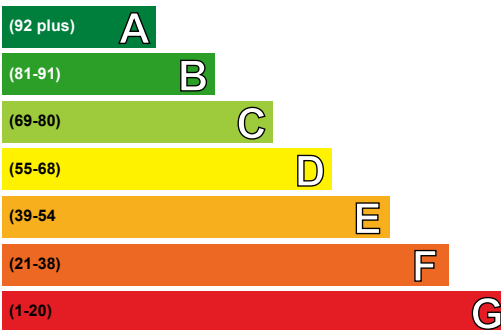
Very energy efficient - lower running costs

Not energy efficient - higher running costs

Current	Potential
59	71

The potential rating shows the effect of undertaking all of the improvement measures listed within your recommendations report.

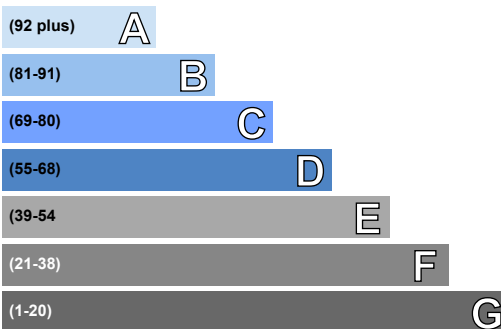
Very environmentally friendly - lower CO₂ emissions

Not environmentally friendly - higher CO₂ emissions

Current	Potential
50	62
