# Home Report

DUNMORE  
3 HARBOUR ROAD  
BRORA  
KW9 6QF

**DUNMORE, 3 HARBOUR ROAD, BRORA, KW9 6QF**

**Dwelling type:** Mid-terrace house  
**Date of assessment:** 10 September 2024  
**Date of certificate:** 10 September 2024  
**Total floor area:** 68 m<sup>2</sup>  
**Primary Energy Indicator:** 844 kWh/m<sup>2</sup>/year

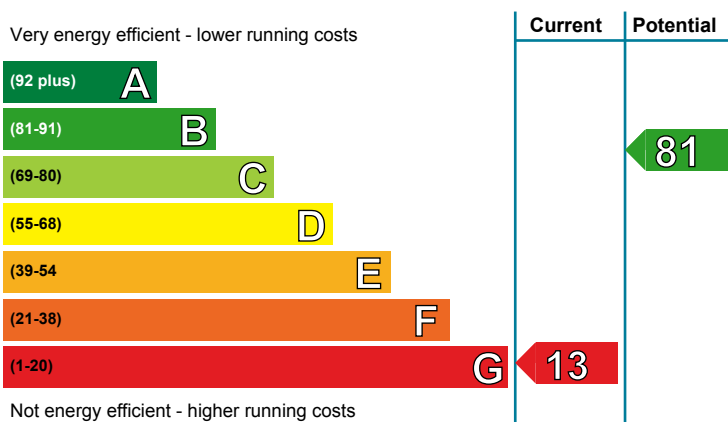
## Energy Efficiency Rating

This graph shows the current efficiency of your home, taking into account both energy efficiency and fuel costs. The higher this rating, the lower your fuel bills are likely to be.

Your current rating is **band G (13)**. The average rating for EPCs in Scotland is **band D (61)**.

The potential rating shows the effect of undertaking all of the improvement measures listed within your recommendations report.

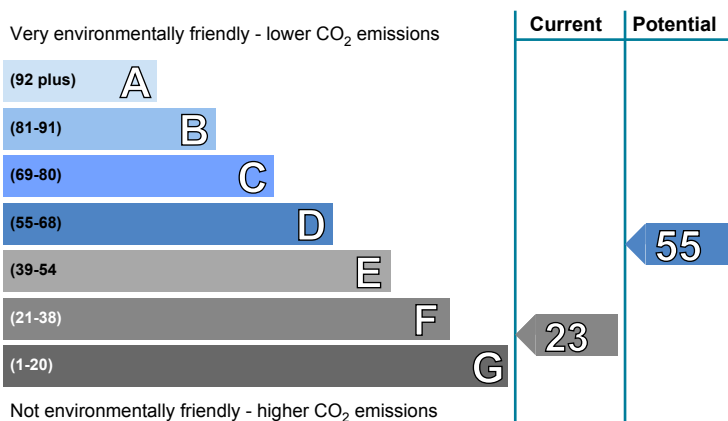
## Environmental Impact (CO<sub>2</sub>) Rating

This graph shows the effect of your home on the environment in terms of carbon dioxide (CO<sub>2</sub>) emissions. The higher the rating, the less impact it has on the environment.

Your current rating is **band F (23)**. The average rating for EPCs in Scotland is **band D (59)**.

The potential rating shows the effect of undertaking all of the improvement measures listed within your recommendations report.
