# Home Report

8 TRENTHAM STREET  
HELMSDALE  
KW8 6JD

**Walker Fraser Steele**  
**Chartered Surveyors**

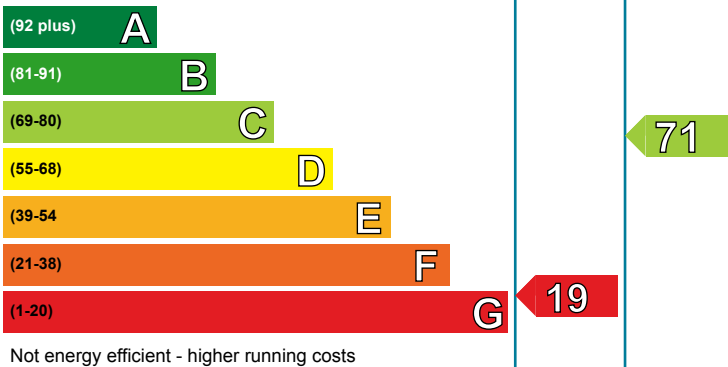
## Energy Efficiency Rating

This graph shows the current efficiency of your home, taking into account both energy efficiency and fuel costs. The higher this rating, the lower your fuel bills are likely to be.

Your current rating is **band G (19)**. The average rating for EPCs in Scotland is **band D (61)**.

The potential rating shows the effect of undertaking all of the improvement measures listed within your recommendations report.

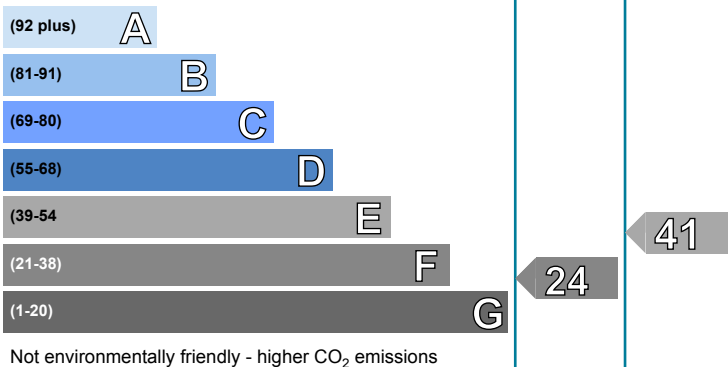
## Environmental Impact (CO<sub>2</sub>) Rating

This graph shows the effect of your home on the environment in terms of carbon dioxide (CO<sub>2</sub>) emissions. The higher the rating, the less impact it has on the environment.

Your current rating is **band F (24)**. The average rating for EPCs in Scotland is **band D (59)**.

The potential rating shows the effect of undertaking all of the improvement measures listed within your recommendations report.
