# Home Report

14 MARKET STREET  
BRORA  
KW9 6PX

**Walker Fraser Steele  
Chartered Surveyors**

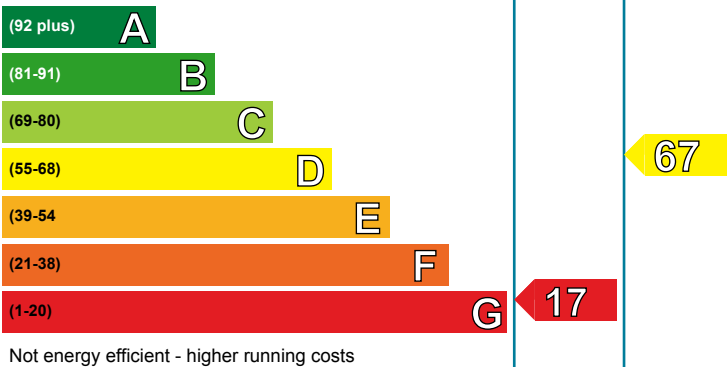
## Energy Efficiency Rating

This graph shows the current efficiency of your home, taking into account both energy efficiency and fuel costs. The higher this rating, the lower your fuel bills are likely to be.

Your current rating is **band G (17)**. The average rating for EPCs in Scotland is **band D (61)**.

The potential rating shows the effect of undertaking all of the improvement measures listed within your recommendations report.

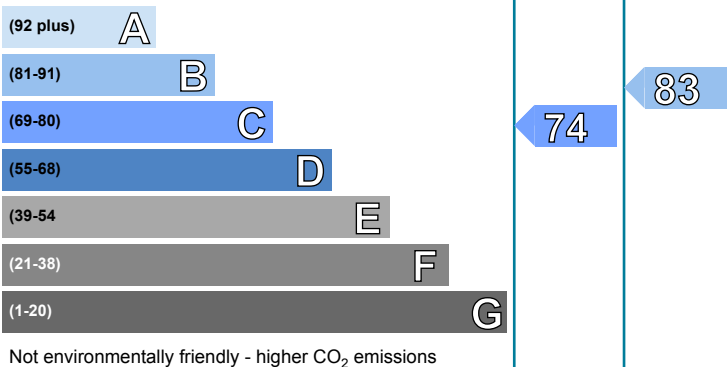
## Environmental Impact (CO<sub>2</sub>) Rating

This graph shows the effect of your home on the environment in terms of carbon dioxide (CO<sub>2</sub>) emissions. The higher the rating, the less impact it has on the environment.

The potential rating shows the effect of undertaking all of the improvement measures listed within your recommendations report.

The average Scottish household produces about 6 tonnes of carbon dioxide every year. Based on this assessment, heating and lighting this home currently produces approximately 2.7 tonnes of carbon dioxide every year. Adopting recommendations in this report can reduce emissions and protect the environment. If you were to install all of these recommendations this could reduce emissions by 0.9 tonnes per year. You could reduce emissions even more by switching to renewable energy sources.
