Energy Performance Certificate (EPC)

GRANITE VILLA, FOUNTAIN ROAD, GOLSPIE, KW10 6TH

Single Survey

Property Address	Granite Villa Fountain Road Golspie KW10 6TH	
Customer	Ms B Kanzig	
Date of Inspection	08/12/2025	
Prepared by	Jennifer Swanson Walker Fraser Steele

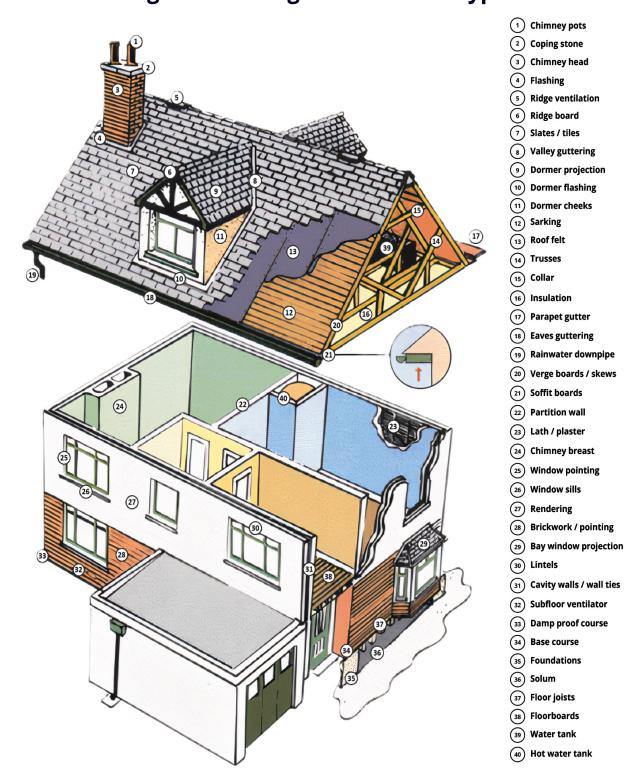
Sectional Diagram showing elements of a typical house

Reference may be made in this report to some or all of the above component parts of the property. This diagram may assist you in locating and understanding these items.
